Prepared Exclusively for Island Point, Inc., No. 1, A Condominium - aka Bay House

As of 09-25-2024 | FPAT File# MUD2423345

# RECAPITULATION OF MITIGATION FEATURES For 644 Island Way, Units 101-708

### **Uniform Mitigation Verification Inspection Form**

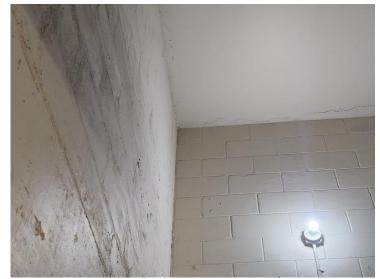
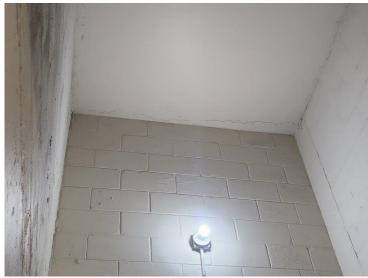
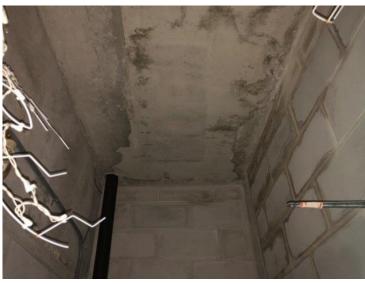
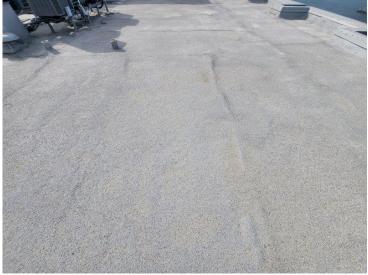
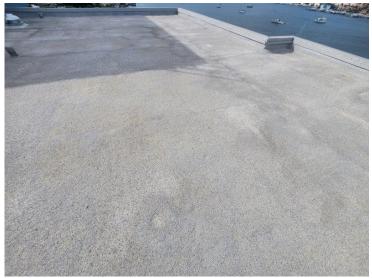
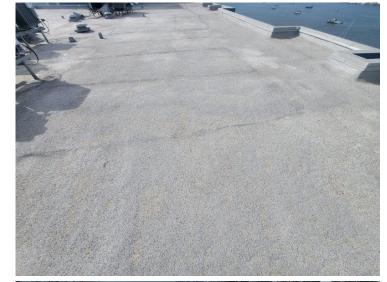
**Roof Construction**

Comments: Inspection verified a roof structure composed of cast-in-place or pre-

cast structural concrete designed to be self-supporting and integrally

attached to the wall / support system.

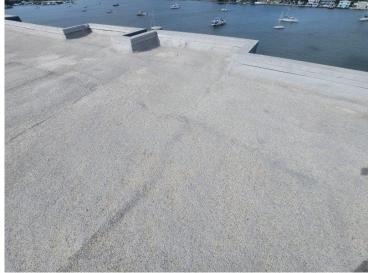
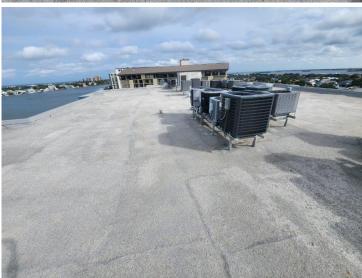
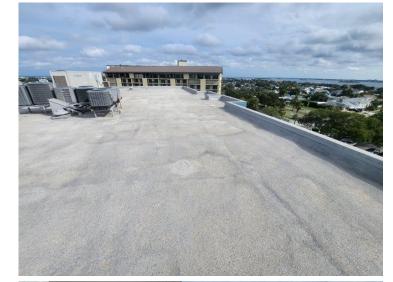
**Roof Construction**

Comments: Inspection verified flat roof shape, refer to attached photographs.
