## COMMERCIAL WINDSTORM MITIGATION REPORT

Island Point, Inc., No. 1, A Condominium - aka Bay House

644 Island Way, Units 101-708

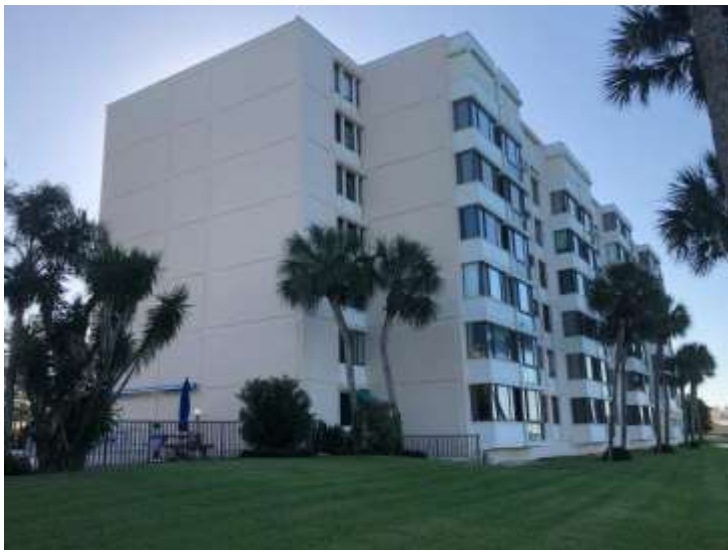
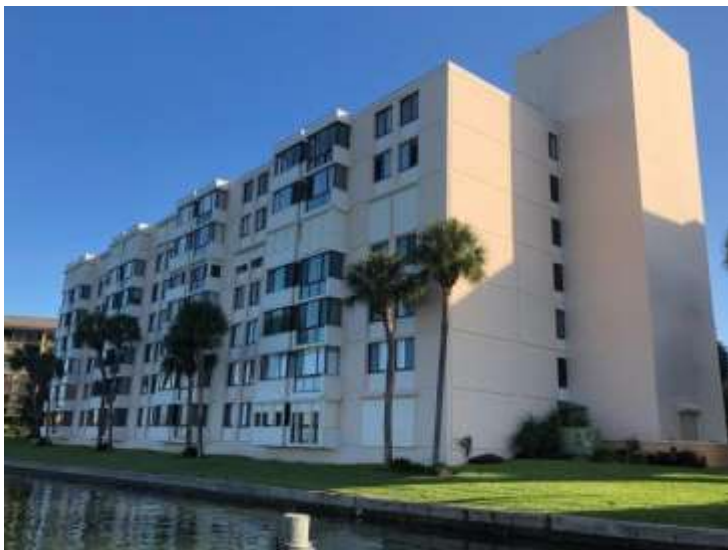
Exterior Elevation

7. **Opening Protection:** **None or Some Glazed Openings**  
Comments: Inspection verified some metal shutter opening protection. Not all glazed openings were protected with impact resistant coverings.

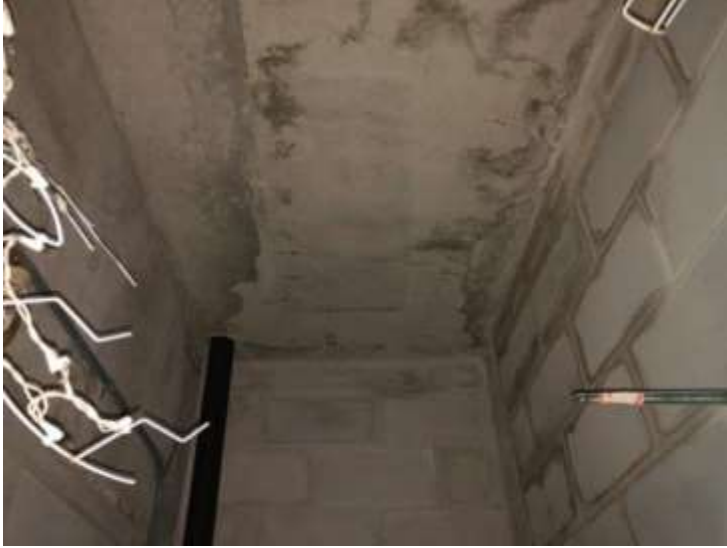
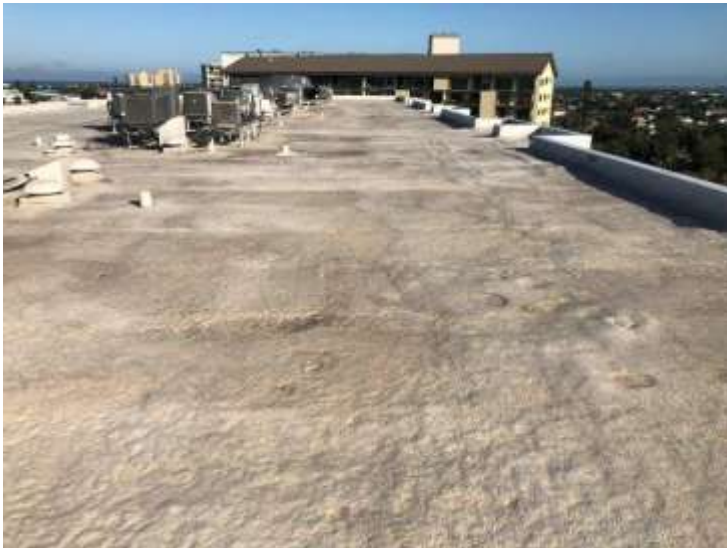
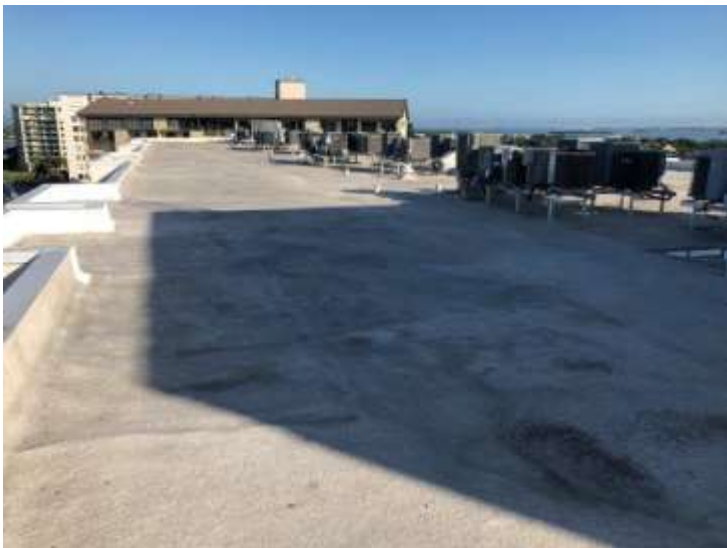
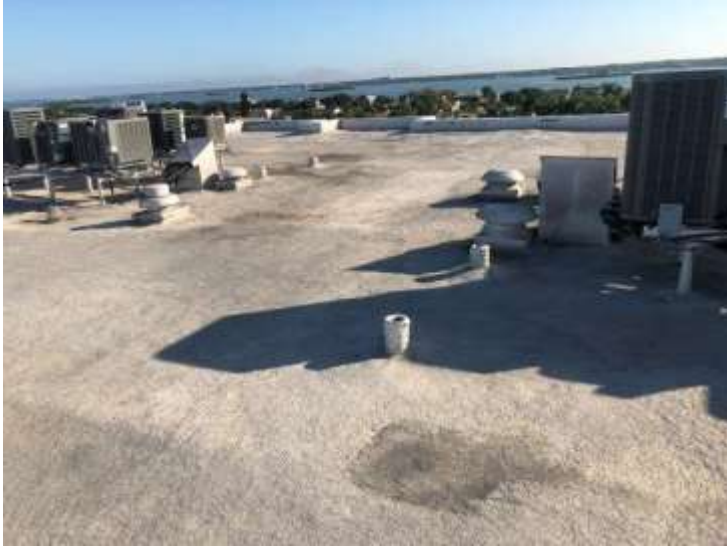
Roof Construction

3. **Roof Deck Attachment:** **Reinforced Concrete Roof Deck**  
Comments: Inspection verified a roof structure composed of cast-in-place or pre-cast structural concrete designed to be self-supporting and integrally attached to the wall / support system.

4. **Roof to Wall Attachment:** **Structural**  
Comments: Inspection verified a roof structure composed of cast-in-place or pre-cast structural concrete designed to be self-supporting and integrally attached to the wall / support system.

5. **Roof Geometry:** **Flat Roof**  
Comments: Inspection verified flat roof shape, refer to attached photographs.
6. **SWR:** **No**  
Comments: SWR does not apply to reinforced concrete roof decks.

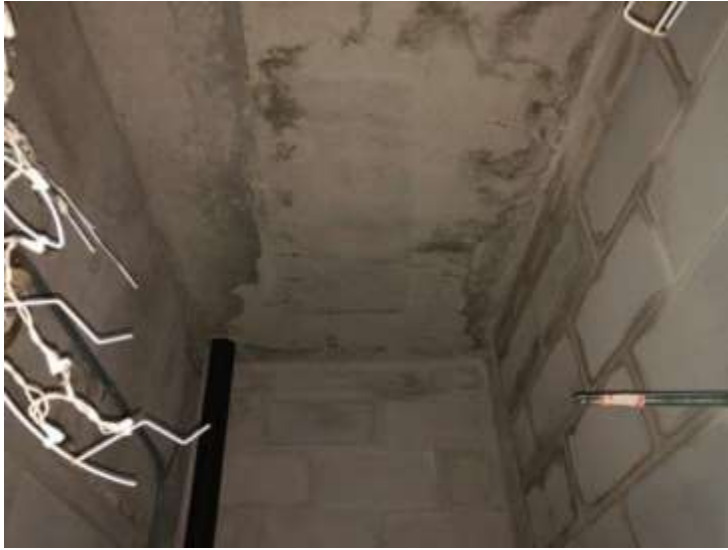
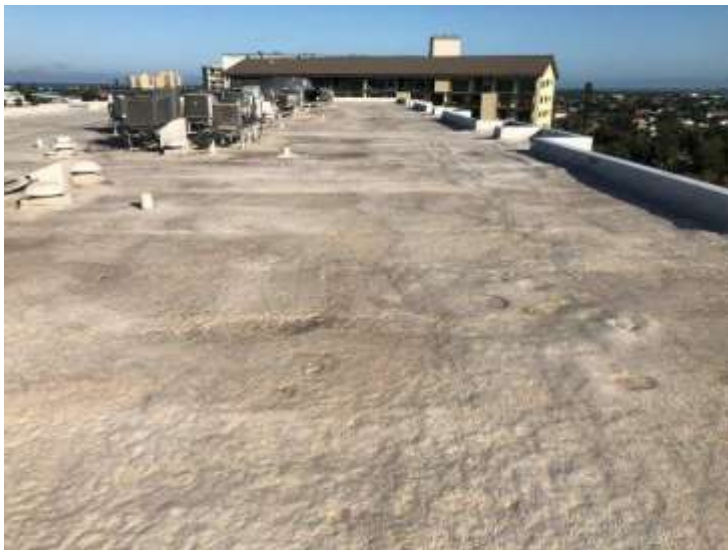
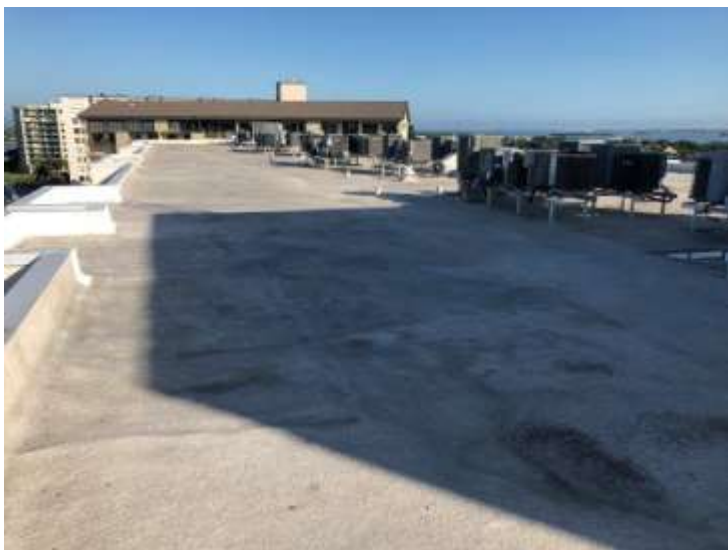
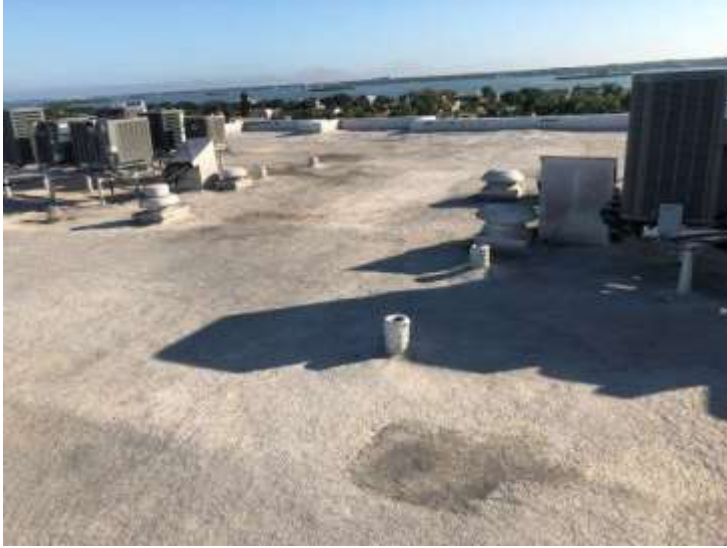
Roof Construction

- 1. Roof Covering:** **FBC Equivalent**  
Comments: The roof covering was replaced in 2013. The roof permit was confirmed and the permit number is BCP2013-04328. This roof was verified as meeting the building code requirements outlined on the mitigation affidavit.
- 2. Roof Deck Attachment:** **Reinforced Concrete Roof Deck**  
Comments: Inspection verified a roof structure composed of cast-in-place or pre-cast structural concrete designed to be self-supporting and integrally attached to the wall / support system.
- 3. SWR:** **No**  
Comments: SWR does not apply to reinforced concrete roof decks.
- 4. Opening Protection:** **None or Some Glazed Openings**  
Comments: Inspection verified some metal shutter opening protection. Not all glazed openings were protected with impact resistant coverings.
